DEPARTMENT OF TRANSPORTATION

Quality Assurance and Source Inspection

Contract #: 04-0120F4Cty: SF/ALA Rte: 80 PM: 13.2/13.9File #: 69.28**WELDING INSPECTION REPORT****Resident Engineer:**Siegenthaler, Peter**Address:** 333 Burma Road**City:** Oakland, CA 94607**Report No:** WIR-022536**Date Inspected:** 04-Apr-2011**Project Name:** SAS Superstructure**OSM Arrival Time:** 700**Prime Contractor:** American Bridge/Fluor Enterprises, a JV**OSM Departure Time:** 1900**Contractor:** Zhenhua Port Machinery Company, Ltd (ZPMC), Changxing Island **Location:** Shanghai, China**CWI Name:** Li Yang**CWI Present:** Yes No**Inspected CWI report:** Yes No N/A**Rod Oven in Use:** Yes No N/A**Electrode to specification:** Yes No N/A**Weld Procedures Followed:** Yes No N/A**Qualified Welders:** Yes No N/A**Verified Joint Fit-up:** Yes No N/A**Approved Drawings:** Yes No N/A**Approved WPS:** Yes No N/A**Delayed / Cancelled:** Yes No N/A**Bridge No:** 34-0006**Component:** Orthotropic Box Girder (OBG)**Summary of Items Observed:**

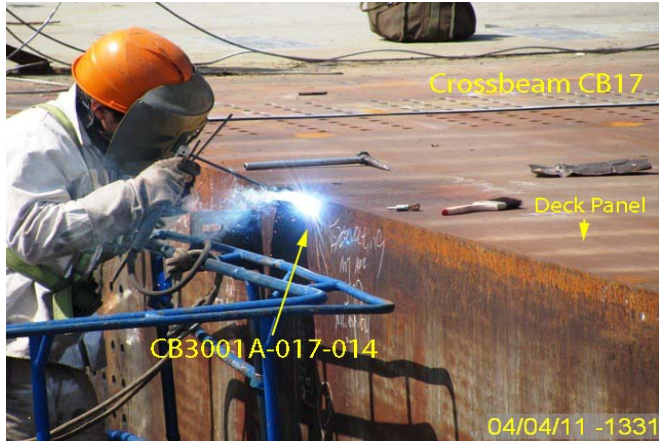
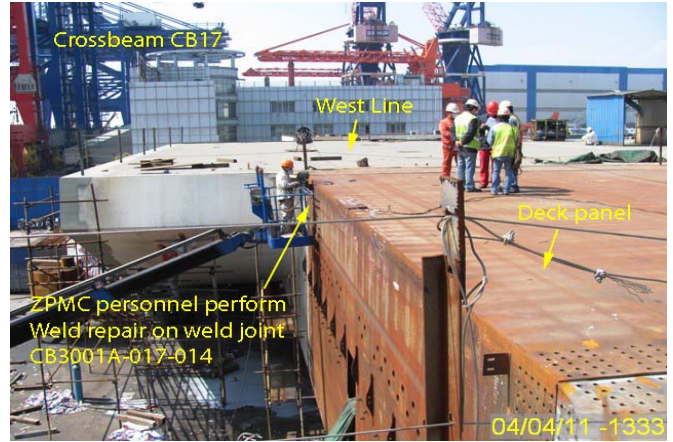
This QA observed ZPMC qualified welding personnel identified as 066459 perform Shielded Metal Arc Welding (SMAW) Process repair welding on weld joint CB3001A-017-014. ZPMC Quality Control Personnel (QC) identified as Mr. Li yang was present to monitor the welding process. The welding parameters as measured using QC's calibrated instruments appeared to be in general compliance with WPS-345-SMAW-2G (2F)-FCM-Repair-1 and Approved Critical Weld Repair B-CWR 2892. See attached photos.
